INDOOR AIR QUALITY ASSESSMENT

**Putnam Vocational Center
1300 State Street
Springfield, Massachusetts**

Prepared by:
Massachusetts Department of Public Health
Bureau of Environmental Health Assessment
September, 2000

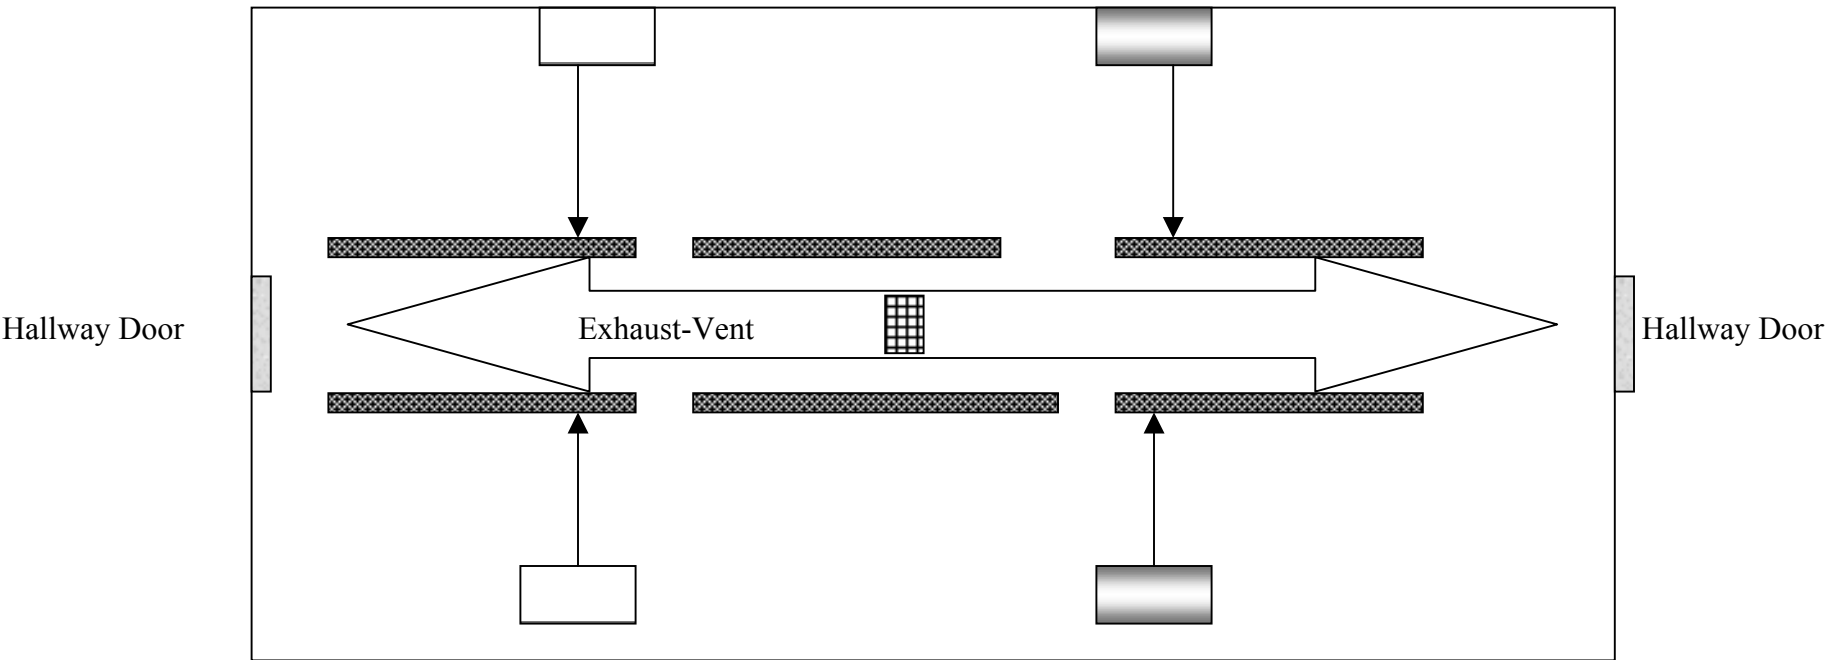
Figure 3

The cosmetology department is located in the basement and serves as a connecting path between the culinary arts program and the remainder of the building complex (see Picture 21). Ventilation is provided by four univents located along the exterior wall. Exhaust ventilation appears to be ceiling mounted vents located in the center of the room. In order to provide privacy for cosmetology students during class, five foot tall floor dividers are used to form a corridor through the center of the cosmetology area (see Figure 3) for occupants to travel to and from the culinary arts department. This floor divider configuration separates/minimizes the draw/removal of cosmetology odors from this area. The practice of cosmetology frequently requires the use of ethanol containing materials for sterilization of equipment purposes as well as methyl methacrylate, which is in nail preparation products. Each of these products contains VOCs. No local dedicated exhaust ventilation exists in this area. The concentrations of total volatile compounds (TVOCs) measured ranged from 0.4 ppm to 248 ppm within the cosmetology area (see Table 25), dependent of the material sampled. (please note that the highest readings were taken 2 inches over an open container of product). TVOCs are the sum concentration of various evaporating VOCs. Products containing VOCs must be used with adequate exhaust ventilation to prevent exposure. During the assessment both the supply and exhaust ventilation systems were deactivated and a strong odor of nail polish was noted. Without dilution and removal via the mechanical ventilation system, these materials can build up resulting in eye and respiratory irritation to sensitive individuals.

General Configuration of Cosmetology Department

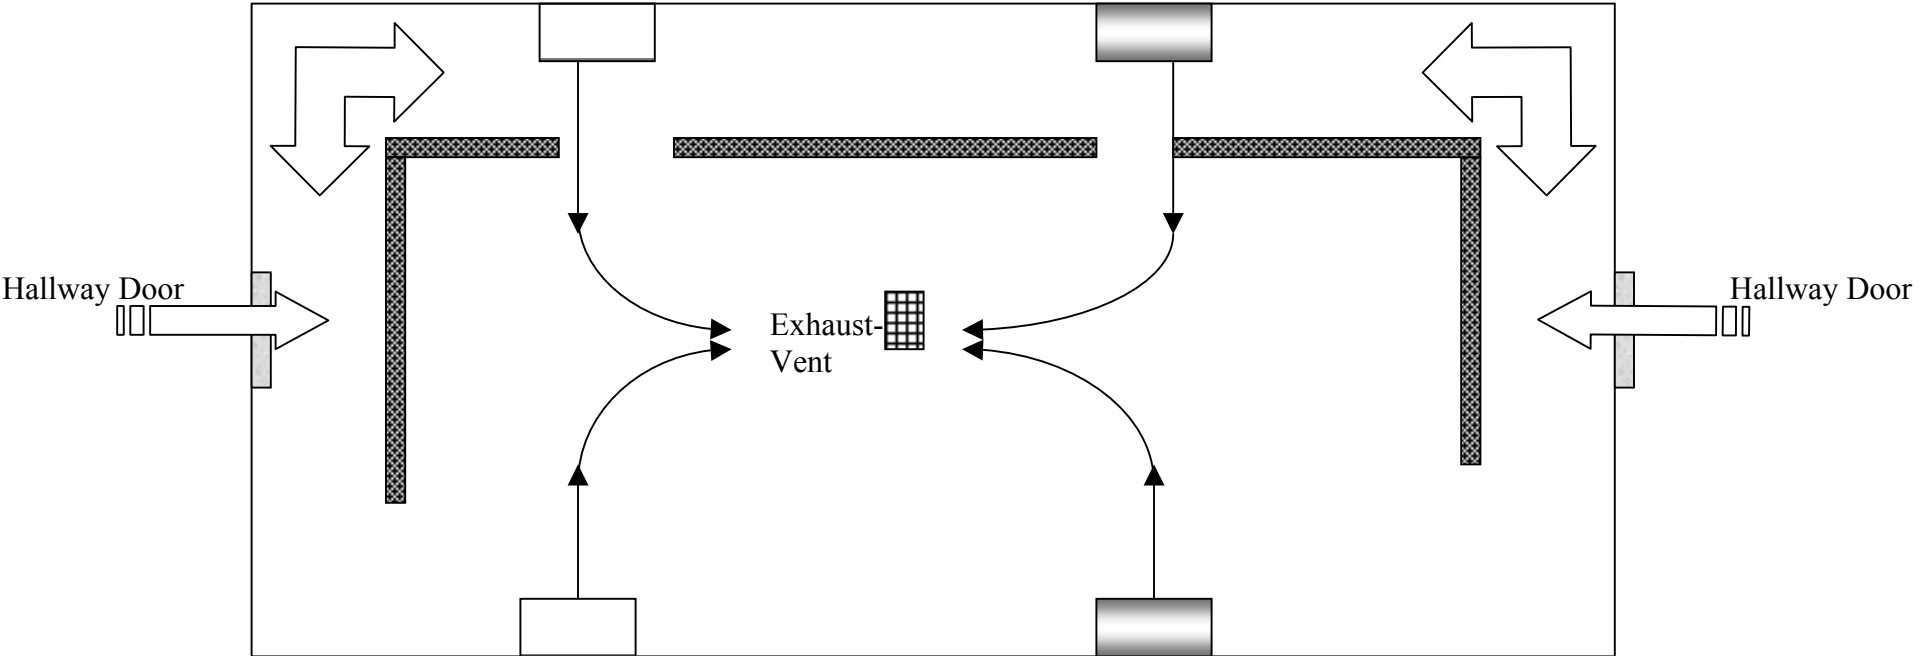
Figure 4

Reconfiguration of Cosmetology Department to Enhance Exhaust Ventilation of Odors

23. Reconfigure the floor dividers in the cosmetology program to enhance airflow and exhaust ventilation of barbering and nail application areas (see Figure 4).

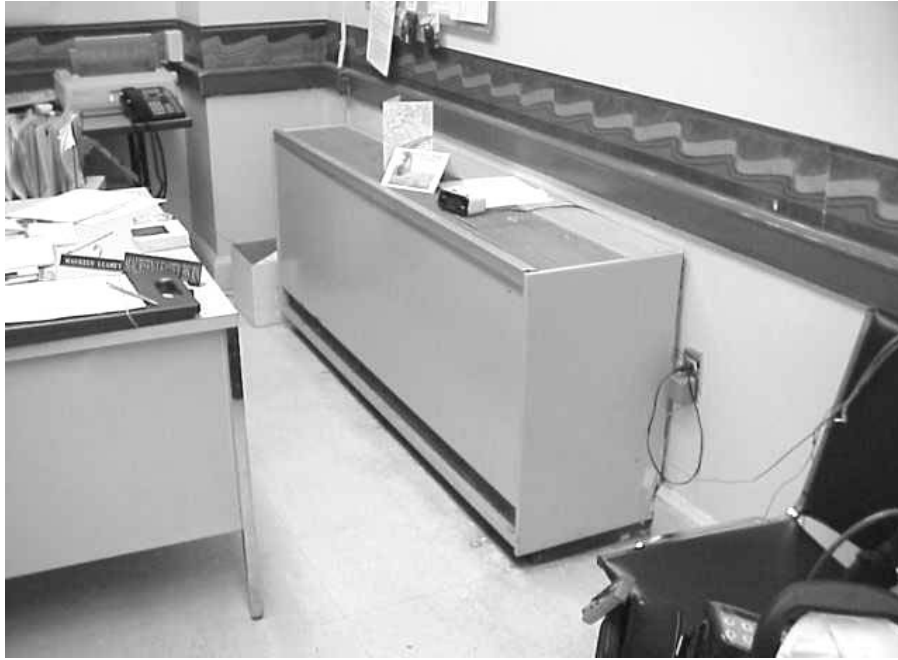
Picture 1

Fresh air in classrooms is supplied by a unit ventilator (univent) system (see Pictures 1 & 2). Univents draw air from outdoors through a fresh air intake located on the exterior walls of the building (see Picture 3) and return air through an air intake located at the base of each unit (see [Figure 1](#)). Fresh air and return air are mixed, filtered, heated and provided to classrooms through a fresh air diffuser located in the top of the unit. Univents were deactivated in the majority of classrooms surveyed (see Tables). Obstructions to airflow, such as books, papers and posters on top of univents, as well as bookcases, tables and desks in front of univent returns, were seen in a number of classrooms. To function as designed, univents and univent returns must remain free of obstructions. Importantly, these units must be activated and allowed to operate during hours of school occupation. A-wing univents appear to be original equipment, approximately 60 years old. Univents were opened in several of these classrooms. None of the univents inspected in A-wing classrooms contained filters (see Picture 4).

Example of Modern Classroom Univent

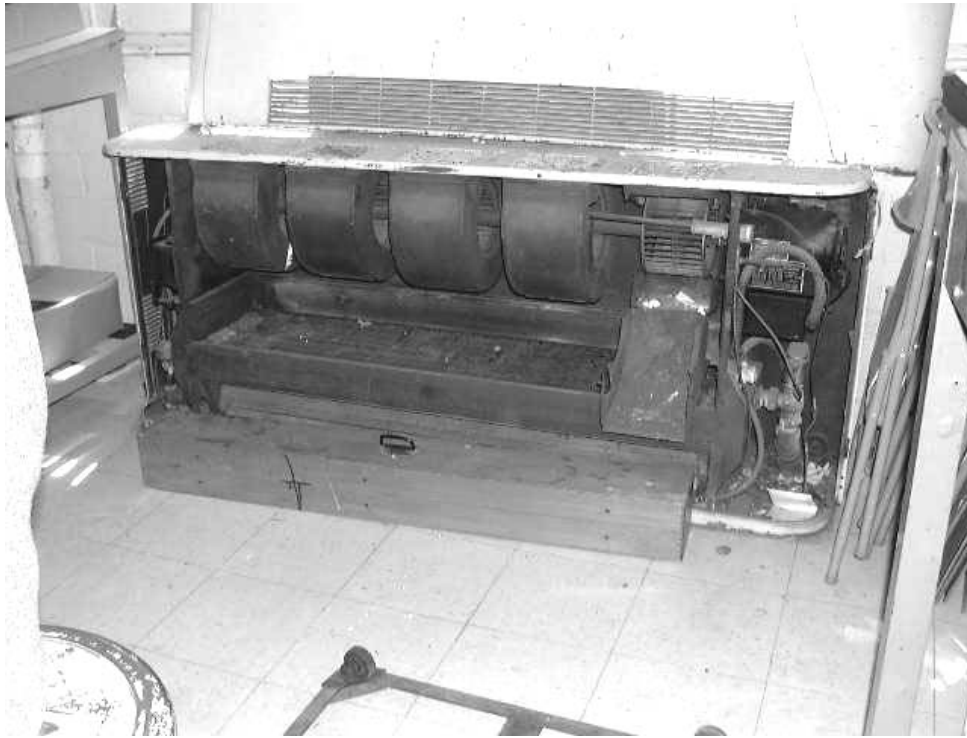
Picture 2

Vintage Classroom Univent Note Front Cover Removed

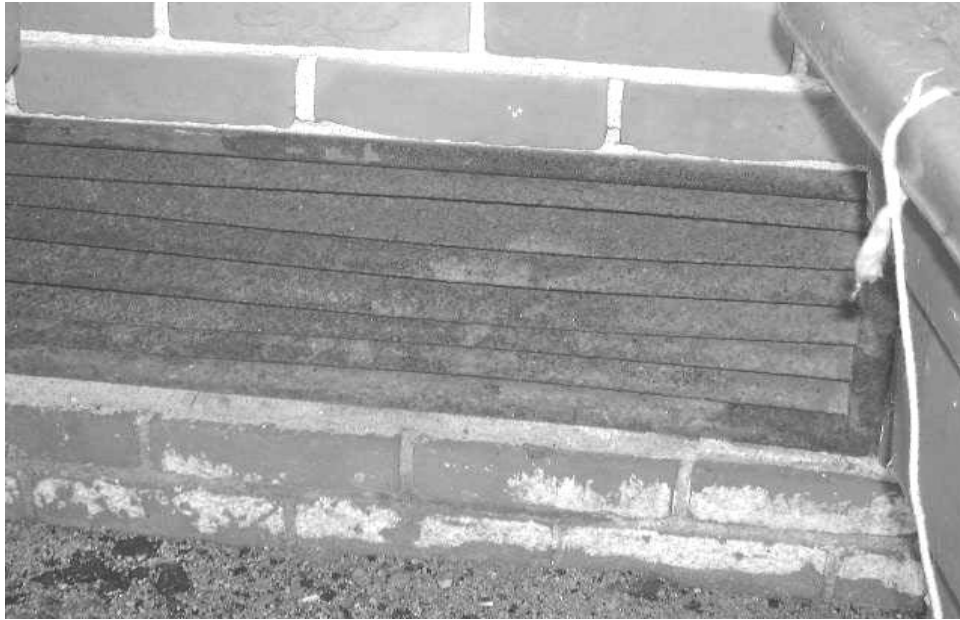
Picture 3

Univent Fresh Air Intake on Exterior Wall

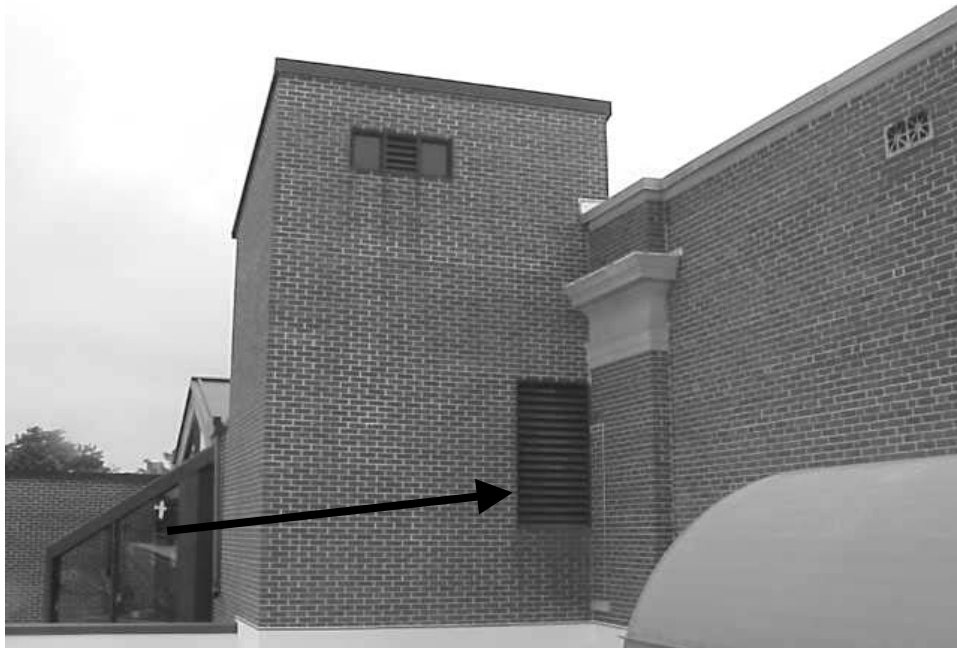
Picture 6

As a general observation, the ventilation systems in the building appear to have thermostats set to deactivate univents at normal operating temperatures. The health center department's thermostats were examined. Each thermostat was set to activate the ceiling mounted vents at 50° F. Adjusting the setting of this thermostat activated the HVAC system in this area. The occupants of the nurse's office nearest the elevator complained of cold air from the univent during winter months. The addition of the H wing and elevator shaft sealed the univent fresh air intake in the nursing office. On the roof in the elevator shaft is a northwest-facing vent (see Picture 6) that appears to be the fresh air intake for this univent. The cover to this exterior vent has fixed louvers. Cold weather systems travelling through New England in the winter generally produce a northwest wind. If a northwest wind is present, the configuration of this vent allows for cold air to be forced down this vent shaft to the univent. With the univent motor deactivated, cold air can backdraft into this area. With the installation of the ceiling mounted air diffuser, the use of the univent system to provide heat and fresh air was rendered redundant.

Fresh Air Intake Vent for the Health Department Office

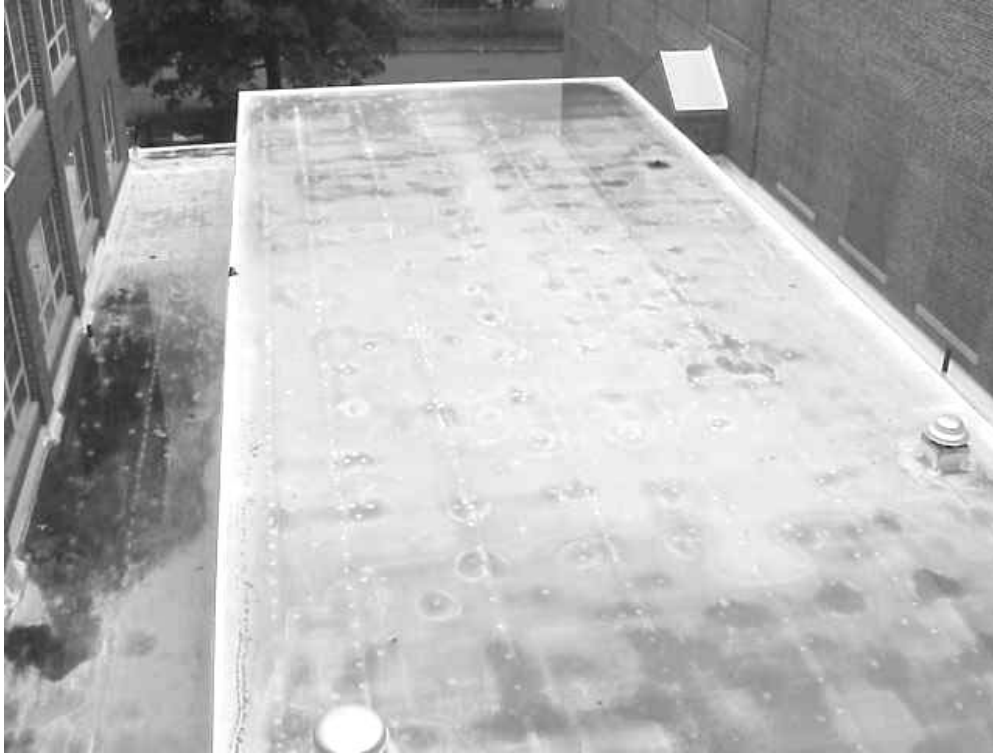
Picture 11

The manner by which the Putnam complex was built led to a design of the roof system that tends to result in water pooling. The front sections of the building consist of wings that form "courtyards" that are enclosed on three sides (see Picture 11). The interiors of these courtyards were filled with low-lying one story roofs (e.g., the roof over the boiler area). Wind and accompanying debris enter the courtyard and tends to swirl, leading to the accumulation of leaves, paper, trash or other debris on the low lying roofs. This debris subsequently collects around roof drains to form small dams that hinder the free flow of rainwater into drains. Over time, debris can enter the roof drainpipe, leading to clogging and back up of water (see Picture 12). Also hindering drainage in some lower-lying roofs is the placement of drains. In several cases, drains were located in the highest point of the roof. In some cases, the roof drain strainer was removed, allowing the accumulation of material in roof drains. Accumulation of materials can lead to blockage and water back up, leading to pooling. Standing water was noted in a number of areas on the roof, including under air handling equipment (see Pictures 13 & 14).

“Courtyard” Formed around Low-Lying Roof

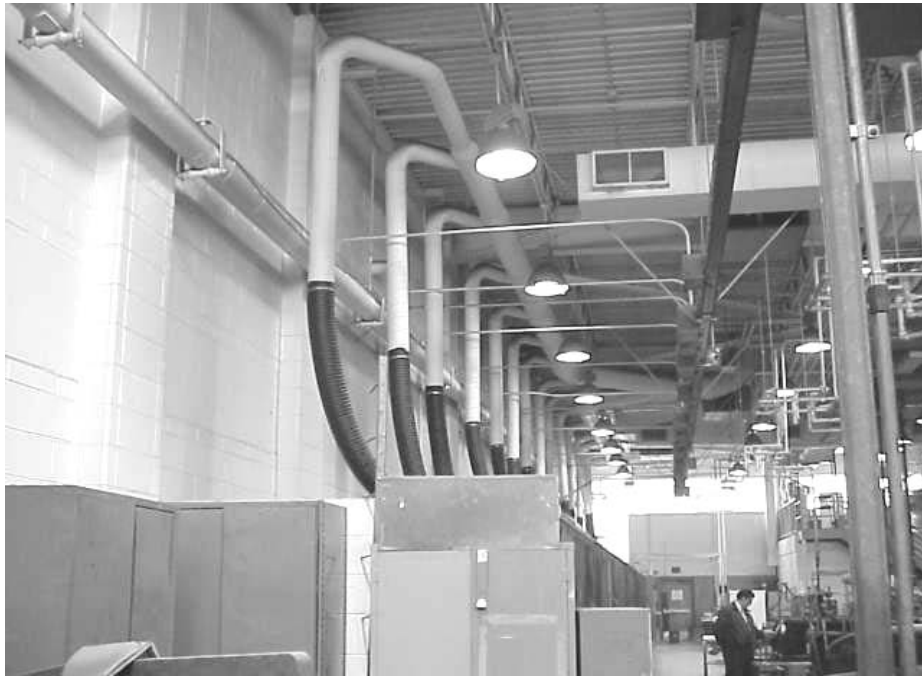
Picture 20

The HVAC shop formerly housed the welding shop, which contains fifteen welding stations connected to a dedicated local exhaust vent system. Shop occupants report local exhaust vent was observed with smoke escaping from a welding booth, despite the presence of a local exhaust ventilation system. Black soot covering the upper surfaces of insulation of pipes along the ceiling is a sign of settling soot, which would confirm occupant observations. This escape of smoke from the welding booth is attributed to the lack of velocity of exhaust ventilation drawn from the elephant trunk vents connected to the exhaust ductwork and fan (see Pictures 20). Air drawn into the welding exhaust vent must make an estimated 450° in curves before reaching the exhaust vent fan above the ceiling. As a general rule, each 90° bend in ducting will reduce the draw of air by 50 percent. In this case, an exhaust hose makes roughly five 90° turns (450°). Assuming that the velocity of the draw of air at the metal ductwork at the top of the flexible hose equals 100 percent, the draw of air at the base of the vent is reduced to roughly 3 percent of the draw because of the five 90° bends in the hose of each welding station. In addition, since there are 15 workstations, the draw of air would be reduced on average to 0.2 percent (3/15). To increase the draw of air and welding pollutants, it is recommended that the exhaust vents for 8 of the welding stations be capped to increase the draw of air by the welding exhaust system. Mechanical metal grinding is conducted in this area. It is reportedly proposed to convert one of the welding workstations to provide local exhaust ventilation for metal grinding.

Configuration of Welding Exhaust Vent Ductwork

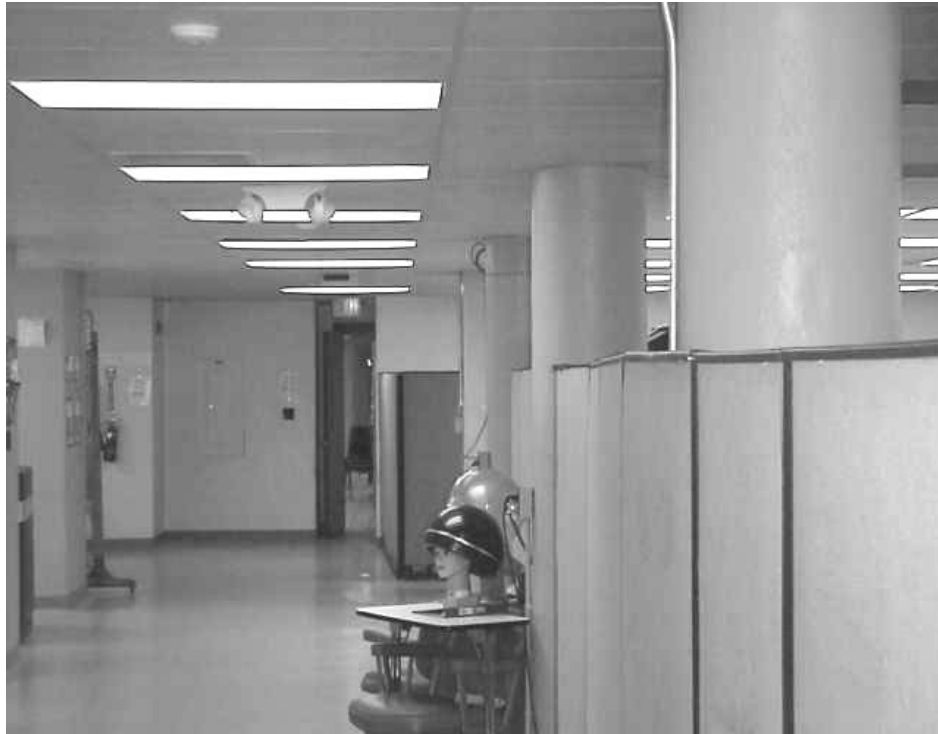
Picture 21

Corridor Formed by Floor Dividers in Cosmetology Department
